**Tree Inventory and Preservation Plan Report
1437 Queen Street West
Toronto, Ontario**

24 April 2023

KUNTZ FORESTRY CONSULTING INC Project P3718

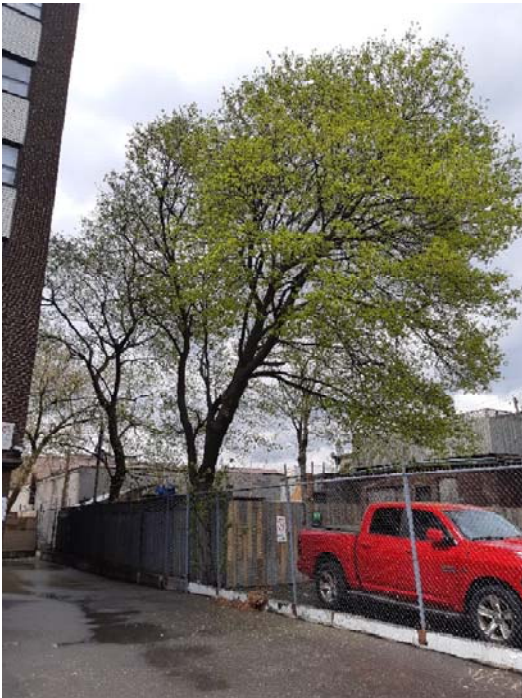
Image 1. Tree 1 (left), Tree 2 (right)

Tree#	Common Name	Scientific Name	DBH	TI	CS	CV	CW	CDB	mTPZ	Cat.	Comments	Action
1	Norway Maple	<i>Acer platanoides</i>	~60	F	F	G	14	5	3.6	1	Co-dominant at 3m and 4m, stem wound (M), pruning wounds (M), deadwood (L), asymmetrical crown (M), cavity (L)	Remove
2	Norway Maple	<i>Acer platanoides</i>	~37	FG	F	G	9.5		2.4	1	Crook (H), broken branches (L), poor form	Remove
3	Tree-of-heaven	<i>Ailanthus altissima</i>	~35	FG	G	G	10.5		2.4	1	Cavity (L), union at 6m	Remove
4	Manitoba Maple	<i>Acer negundo</i>	~43	FG	G	G	12		3	2	Lean (M) north, stem wound (L), deadwood (L), co-dominant at 6m	Retain (injure)
5	Manitoba Maple	<i>Acer negundo</i>	~45	F	F	F	11	10	3	2	Bow (M) west, stem wound (M) with rot, pruning wounds (M) with rot, deadwood (L), fruiting body, coppice growth (M)	Retain (injure)
6	Tree-of-heaven	<i>Ailanthus altissima</i>	40	F	G	G	8.5		2.4	1	Co-dominant at 1.6m with included bark, 5 stems, broken branches (L), growing against building, impervious surface in root zone	Remove

The removal of Trees 1-3 and 6-11 will be required to accommodate the proposed development. These trees conflict directly with the proposed construction including subsurface parking/shoring.

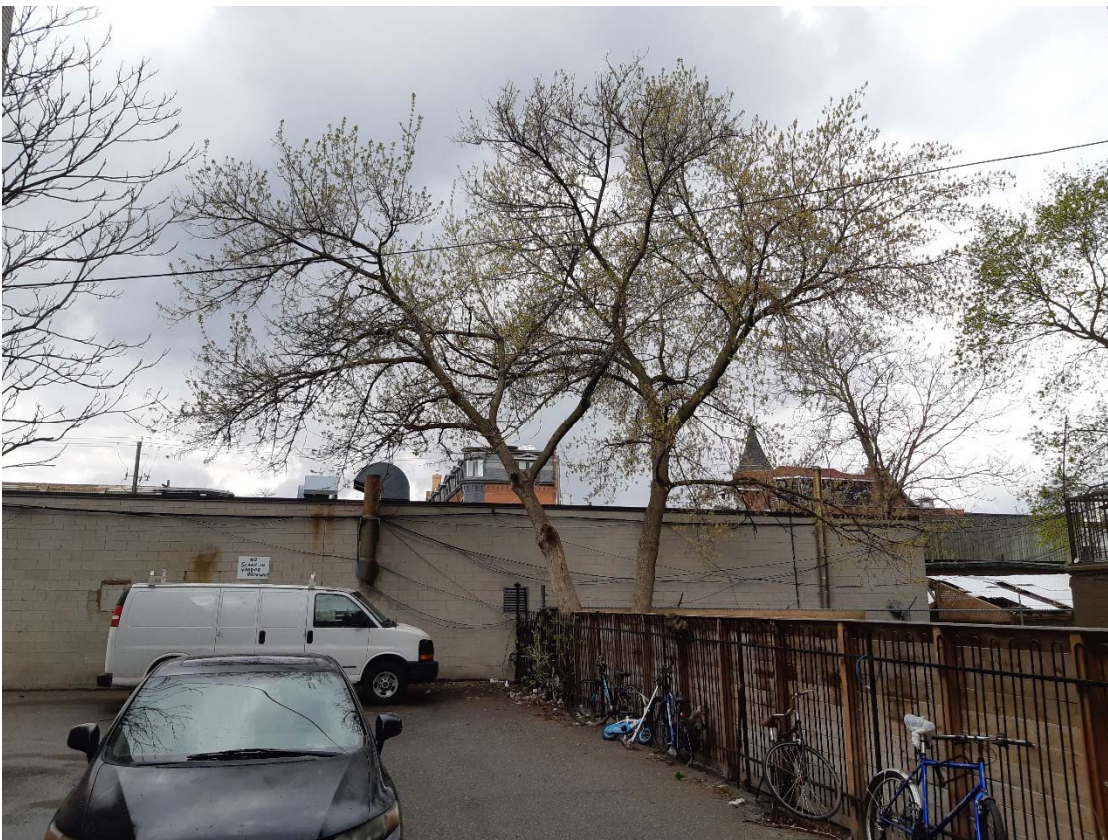
Image 3. Tree 4 (left), Tree 5 (right)

Excavation into the minimum tree protection zone (mTPZ's) of Trees 4 and 5 will be required to accommodate shoring. These trees are located on neighbouring properties and are greater than 30cm DBH (Category 2 trees). A permit to injure these trees will be required.

There is existing asphalt/concrete on the subject property within their mTPZ's; as such, we would not expect substantial roots to be growing onto the subject site and into the disturbance zone. However, the following mitigation measures are required to ensure the trees respond well to construction:

- The tree protection fencing as shown on Figure 1 must be installed and maintained throughout construction.
- The existing building adjacent to these trees should be demolished carefully to avoid injury to these trees; crown pruning should occur prior to demolition if required.
- The existing asphalt/concrete within the mTPZ's of these trees should be removed carefully, by hand or using small equipment (ie. a skidsteer).
- Excavation to occur within the gravel subsurface and the soil below within mTPZ's of these trees must occur by air spading and be supervised by a certified Arborist. This must occur to a depth of 90cm if possible. Excavation below this limit can occur via traditional means.
- Exposed roots must be pruned in accordance with Good Arboricultural Standards.
- Any crown pruning should occur by a certified Arborist in accordance with Good Arboricultural Standards.

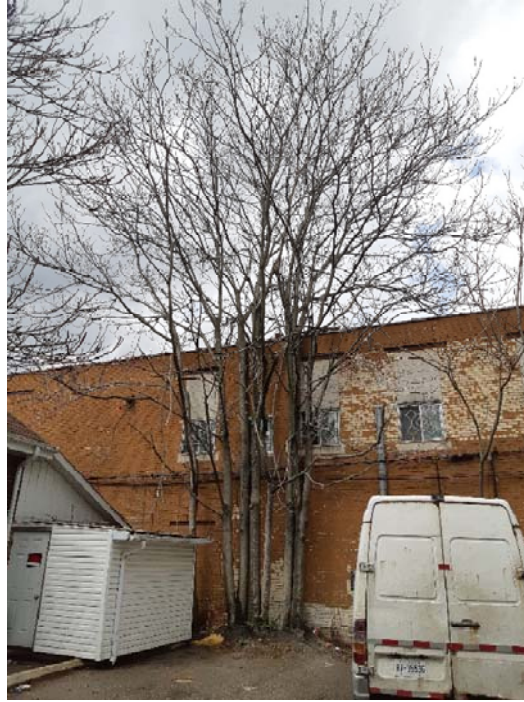
Image 6. Trees 7-10 (right-left)

7	Tree-of-heaven	<i>Ailanthus altissima</i>	28.5, 26.5	FG	FG	FG	9		1.8	-	Co-dominant at 0.3m with included bark and 3.5m, broken branches (M), growing against building, impervious surface in root zone	Remove
8	Tree-of-heaven	<i>Ailanthus altissima</i>	28, 18	FG	FG	FG	10		1.8	-	Co-dominant at 0.2m with included bark, broken branches (L), deadwood (L), growing against building, impervious surface in root zone	Remove
9	Tree-of-heaven	<i>Ailanthus altissima</i>	25, 24	FG	FG	FG	7		1.8	-	Co-dominant at 0.3m with included bark, broken branches (L), growing against building, impervious surface in root zone	Remove
10	Tree-of-heaven	<i>Ailanthus altissima</i>	22.5	G	FG	FG	7.5		1.8	-	Crook (L), growing against building, impervious surface in root zone	Remove
11	Tree-of-heaven	<i>Ailanthus altissima</i>	~28, 14	F	FG	FG	9		1.8	-	Union at 0.4m with included bark, Included fence (H), sweep (L), impervious surface in root zone	Remove
